STATE OF ILLINOIS DEPARTMENT OF TRANSPORTATION

BEARING SHOULDER BOLT REPAIR DETAILS FAI ROUTE 180 OVER ILLINOIS RIVER SECTION (06-3,78-1)I-2 BUREAU/PUTNAM COUNTIES S.N. 078-0001

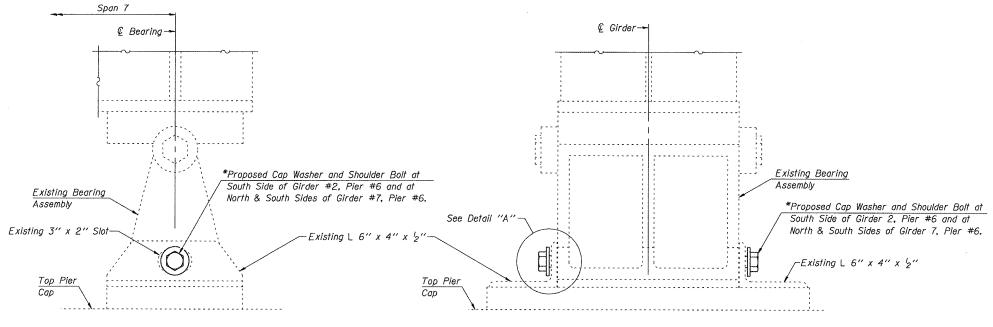
EXISTING BEARING AT PIER 6

The Existing Shoulder Bolts at the designated locations have failed. The threaded portions of the failed Shoulder Bolts are embedded in the Existing Bearing Assemblies and are to be removed to allow installation of new Shoulder Bolts. The cost for tapping holes for new Shoulder Bolts, if required, and removing the embedded portions of the failed Shoulder

After the embedded portions of the failed Shoulder Bolts have been

examine the removed portions of the bolts and the holes in the Existing

Bearing Assemblies to determine thread requirements for the new Shoulder Bolts. If bolt removal operations damage the threaded holes in the Existing Bearing Assemblies, holes shall be re-tapped as needed to accept

removed from the Existing Bearing Assemblies, the Contractor shall

new Shoulder Bolts.

Bolts in the Existing Bearing Assemblies is included in Structural Steel Repair.
